**BUILDING CONDITION REPORT**  
**25 VINCENT, CHAUTAUQUA**  
**SEPT, 2023**

# 25 Vincent Ave

## 2020 Residential Code of New York synopsis

## 25 Vincent Ave Summary 09.25.2023

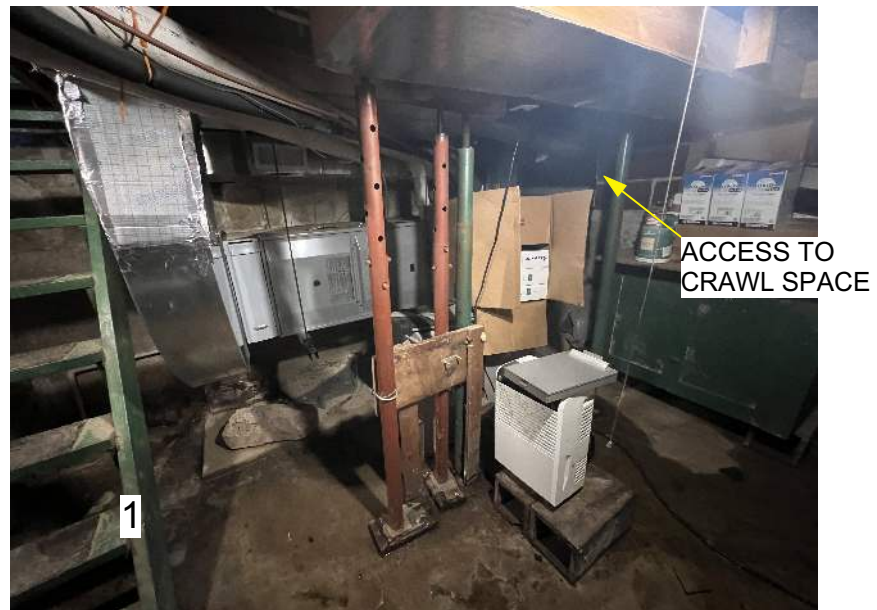
BASEMENT - NOTICE TEMP SUPPORT POSTS AND EXTREMELY CRAMPED CONDITIONS

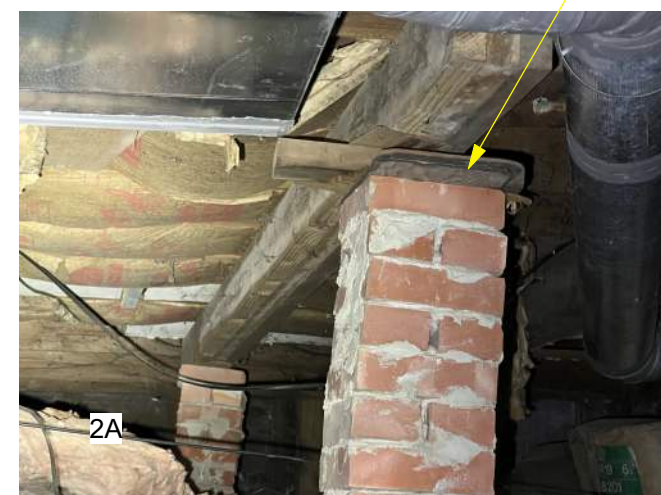
NOTICE POOR PIER CONSTRUCTION QUALITY

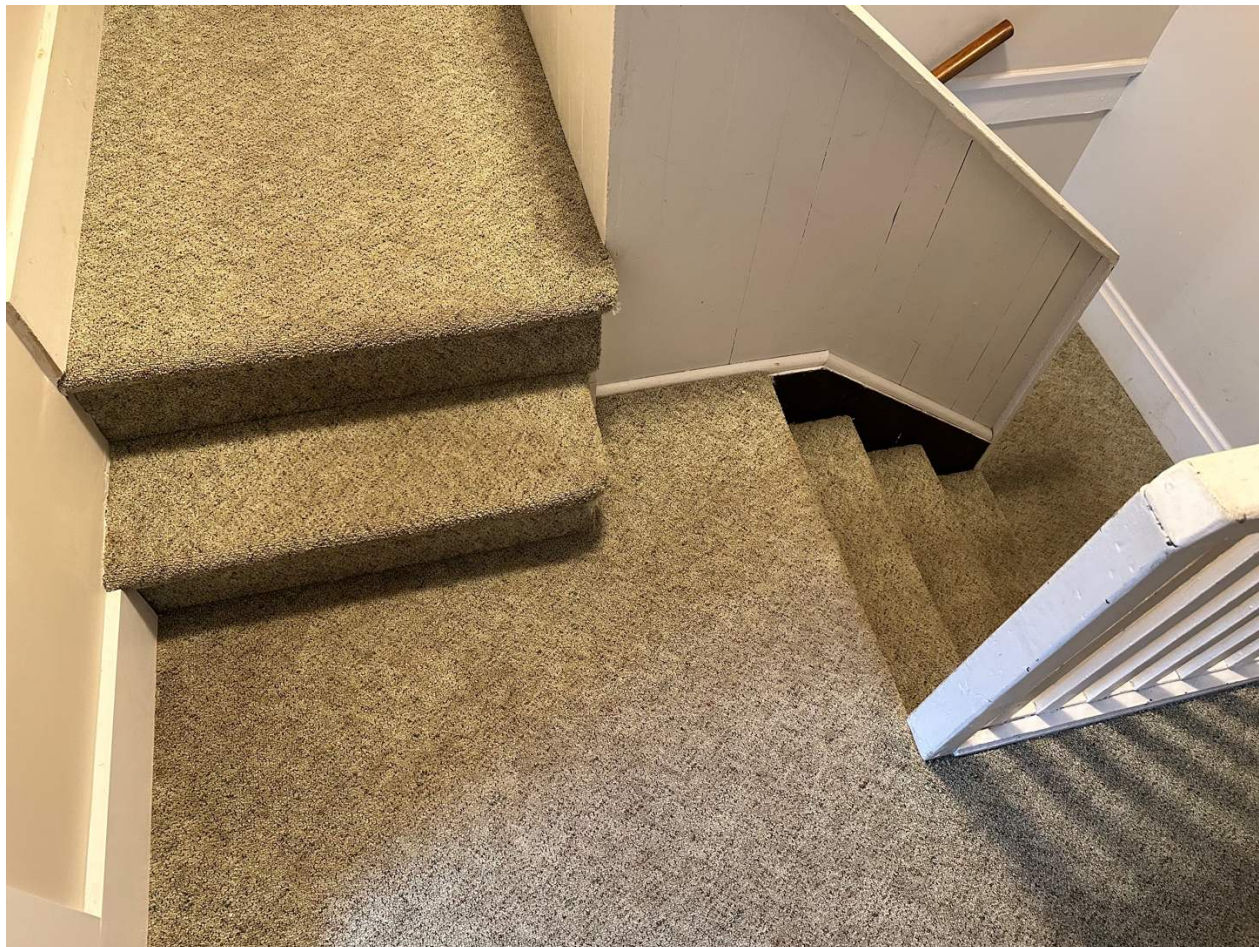
- a. Width is noncompliant > 36" ranges between 30" and 28"
- b. Headroom is not compliant > 80" it is 64"

- c. Handrails are noncompliant, only exist on the first run but are mounted below the 34" minimum
- d. Risers are not compliant they vary > 3/8" on all runs

Unsafe Stairs

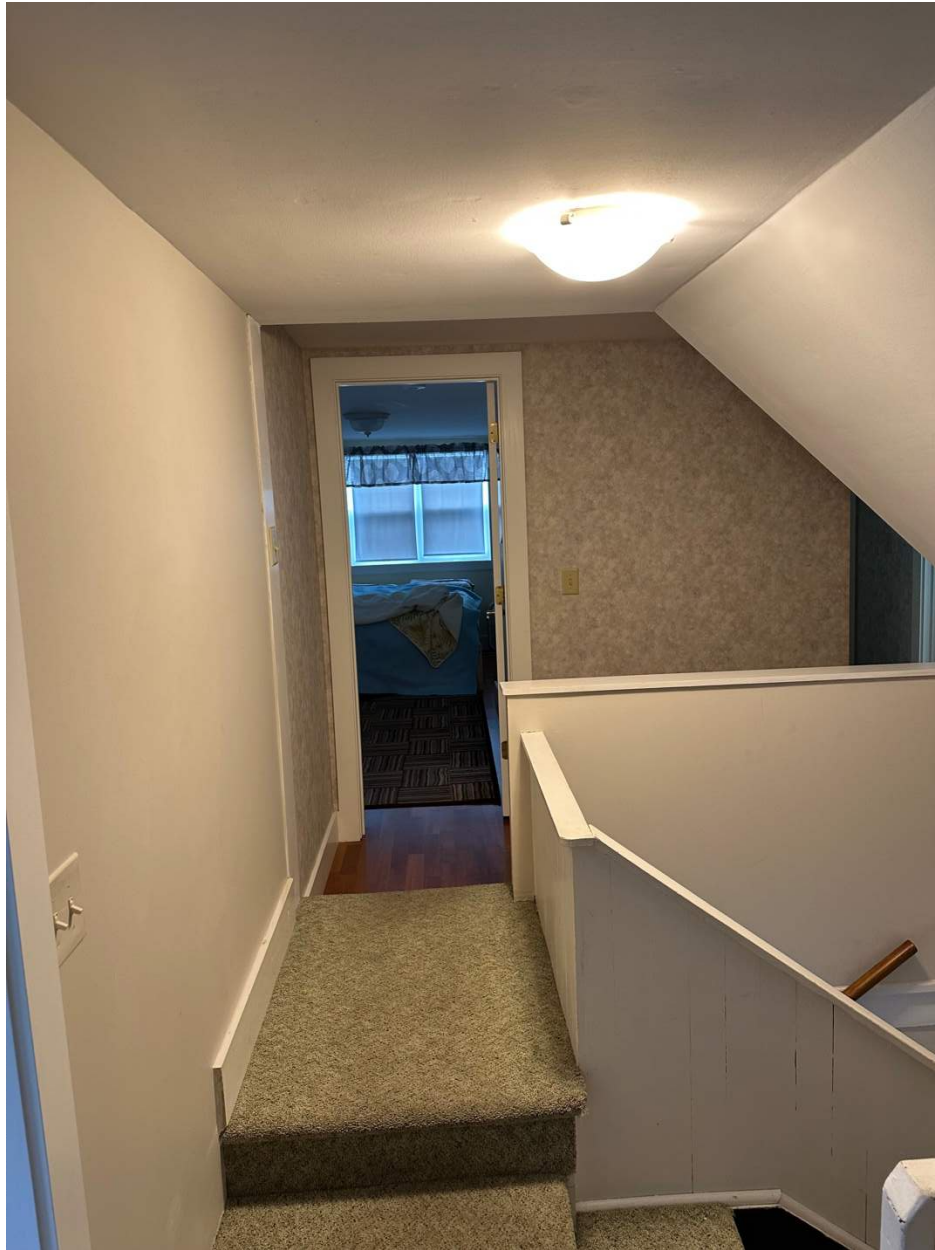
- R305 Ceiling Heights 7'0" minimum in living areas 6'8" in baths and laundry areas
- a. Ceiling heights vary from 7'0" to 7'3" in the older portion of the building
  - b. Ceiling heights vary from 7'6" to 7'9" in the newer portion of the building
  - c. Ceiling heights vary in the second floor bathroom's from 6'4' to 7'0'
  - d. Ceiling height at the tom of the stairs is 6'0"

Inadequate Ceiling Hieght

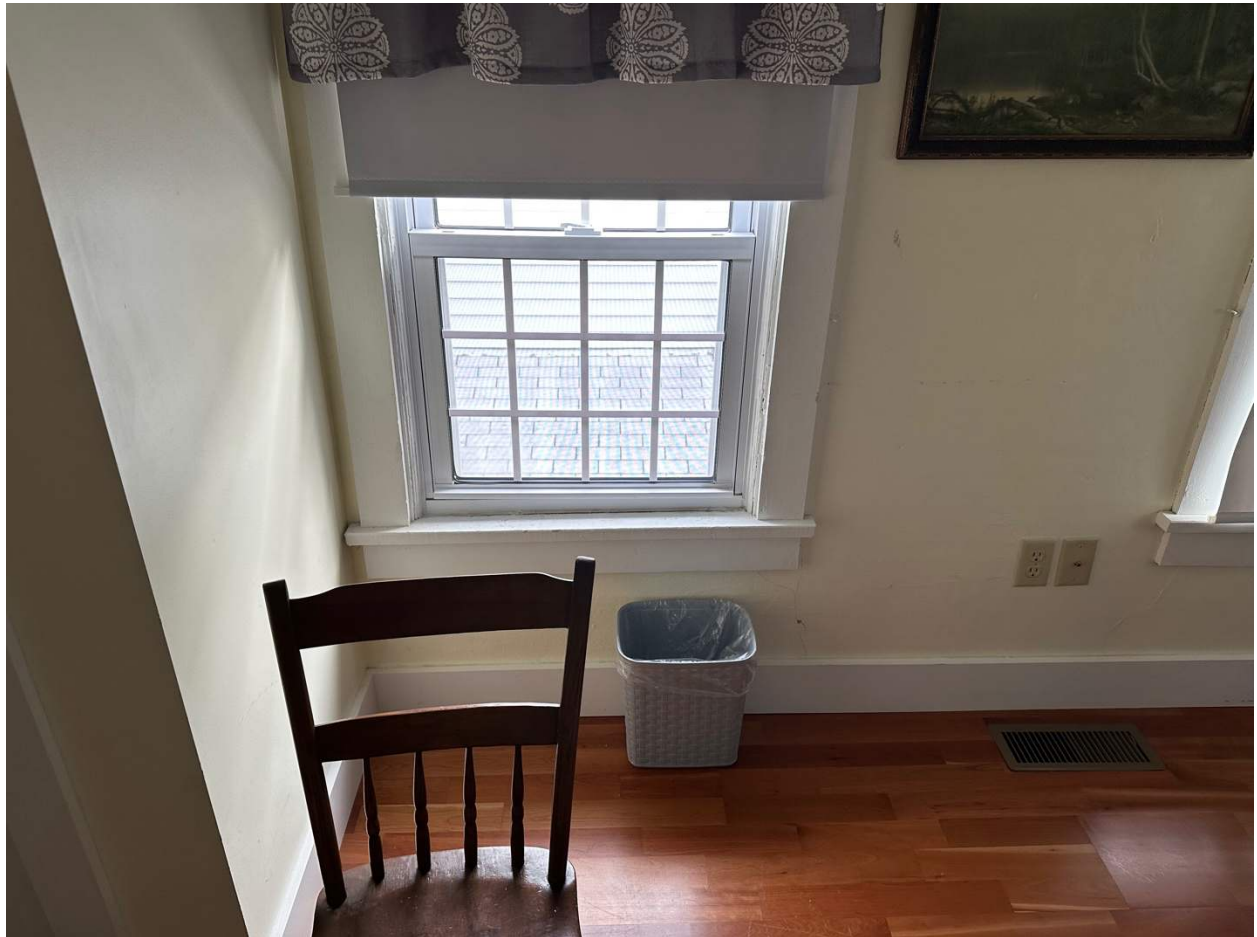
- a. Both back bedrooms do not have code compliant Emergency Escape and Rescue openings
- b. The two front bedrooms do have doors that lead to the front porch but they have been blockaded due to an either real or perceived fear of the structural stability of the second story porch. Investigative demolition would allow analyses, but structural movement experienced when walking on the surface of the porch would lead one to believe it has been compromised.

Non Compliant Means of egress, also not compliant with the ALU vinyl replacement

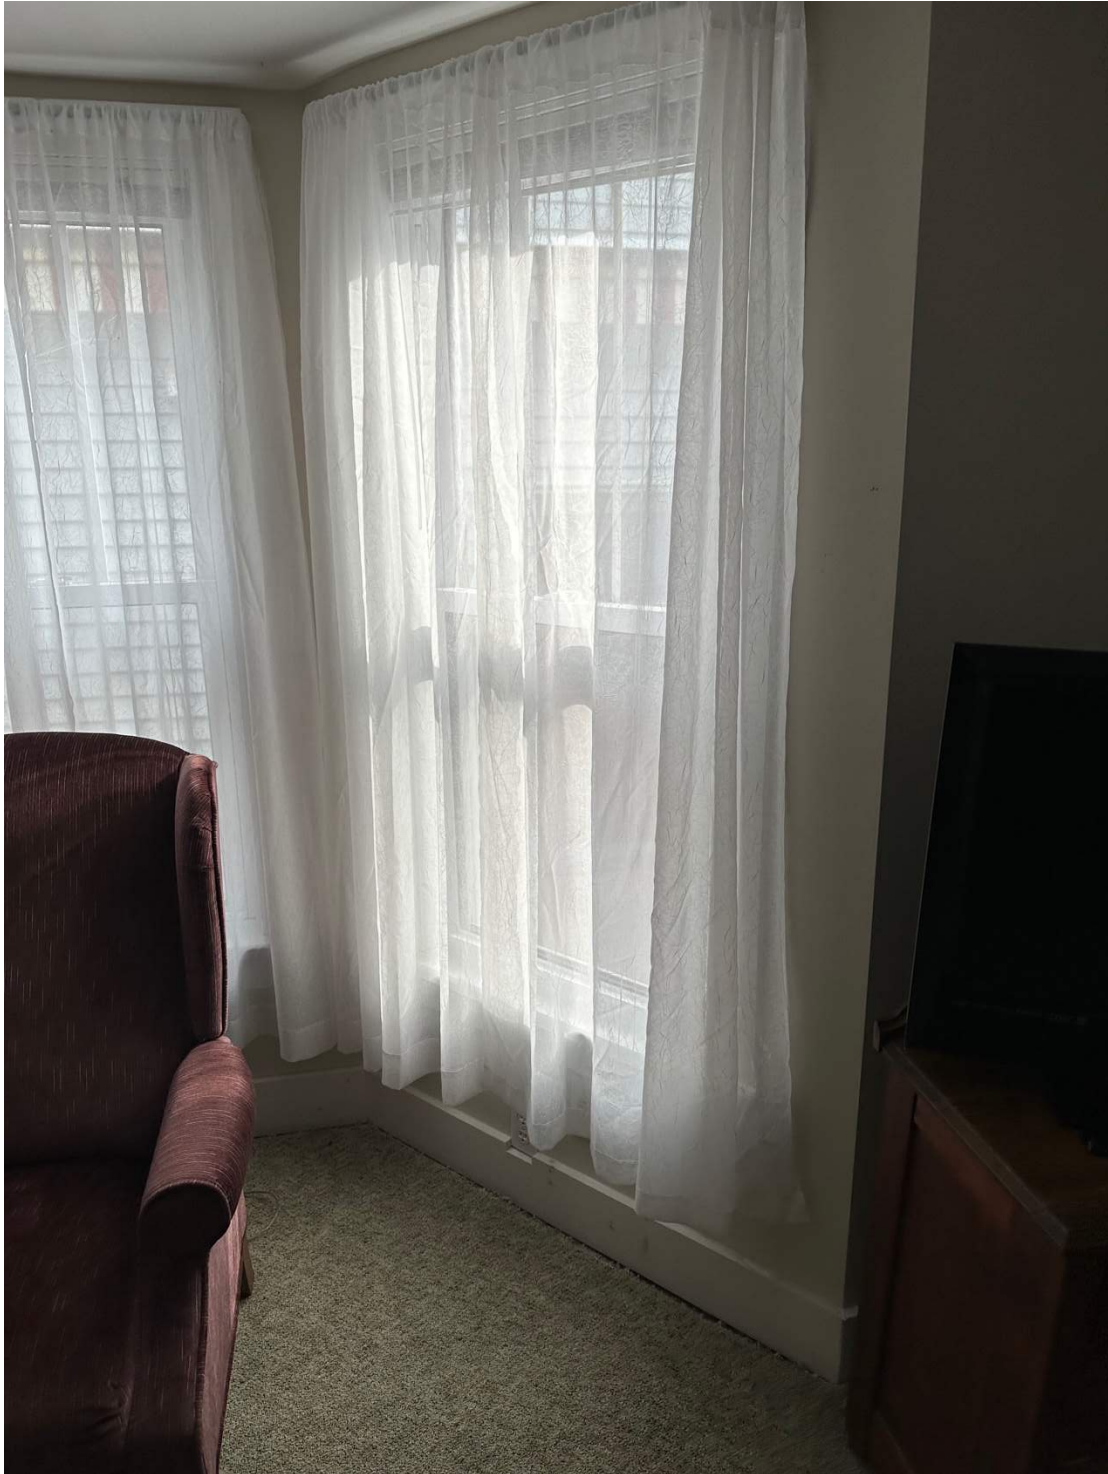
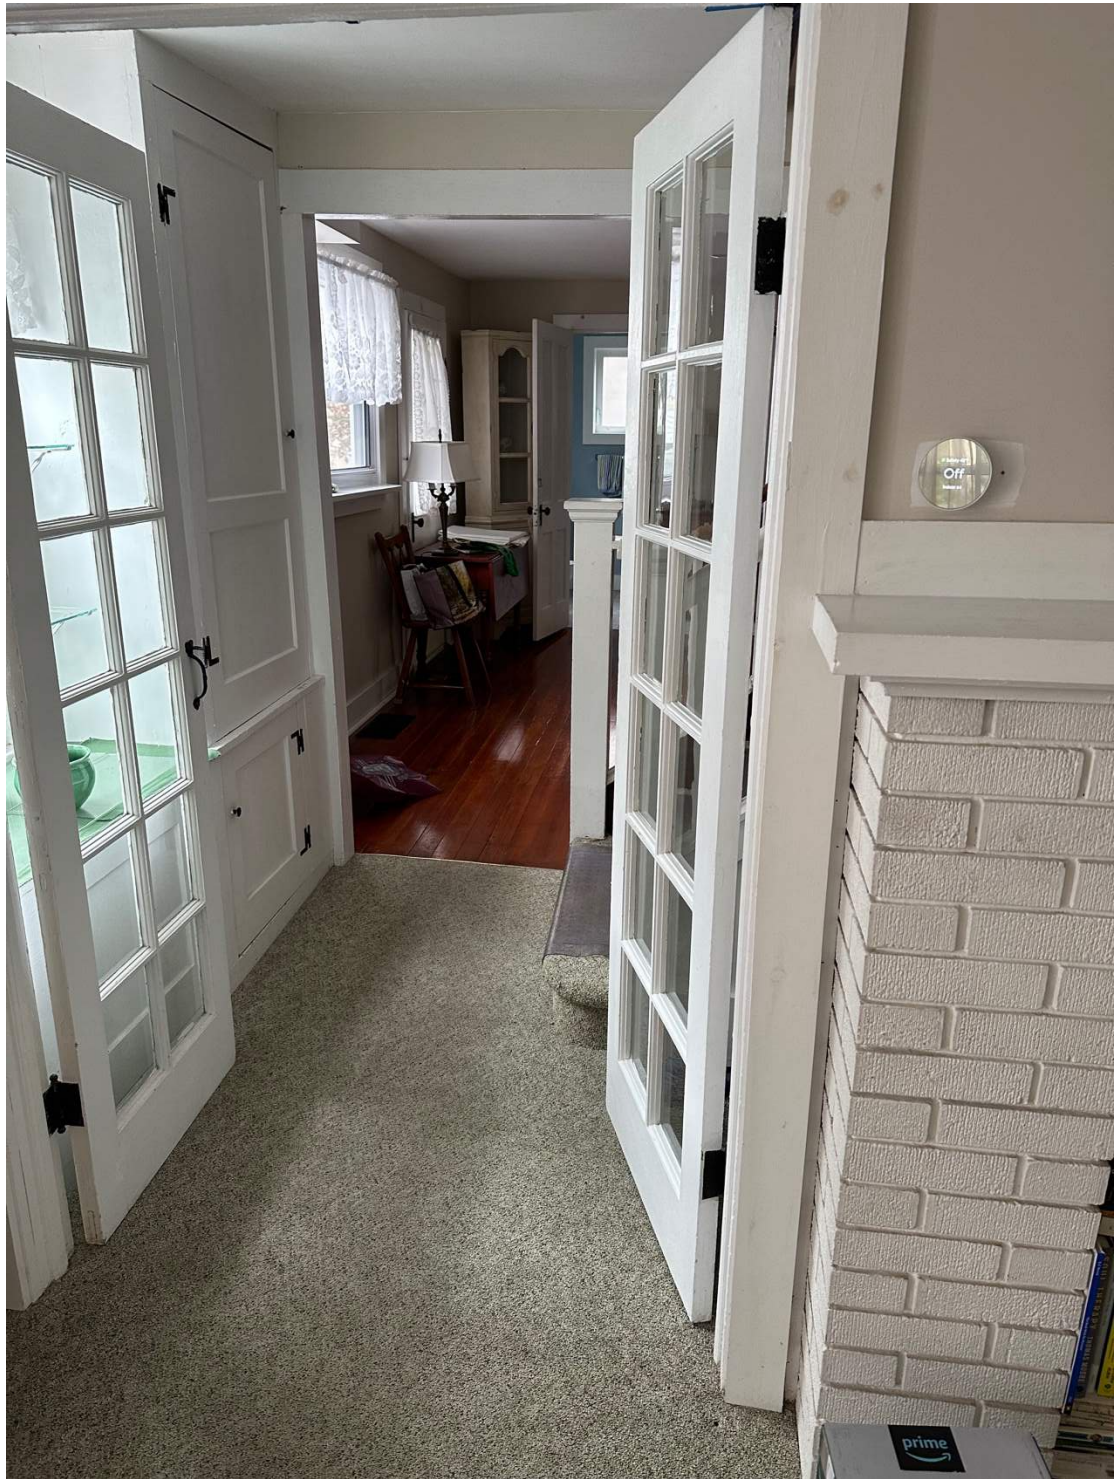
- a. Hazardous Glazing exist in multiple locations throughout the home, either too close to the floor and un-tempered, or too close to the stairs.

## Unsafe Gazing

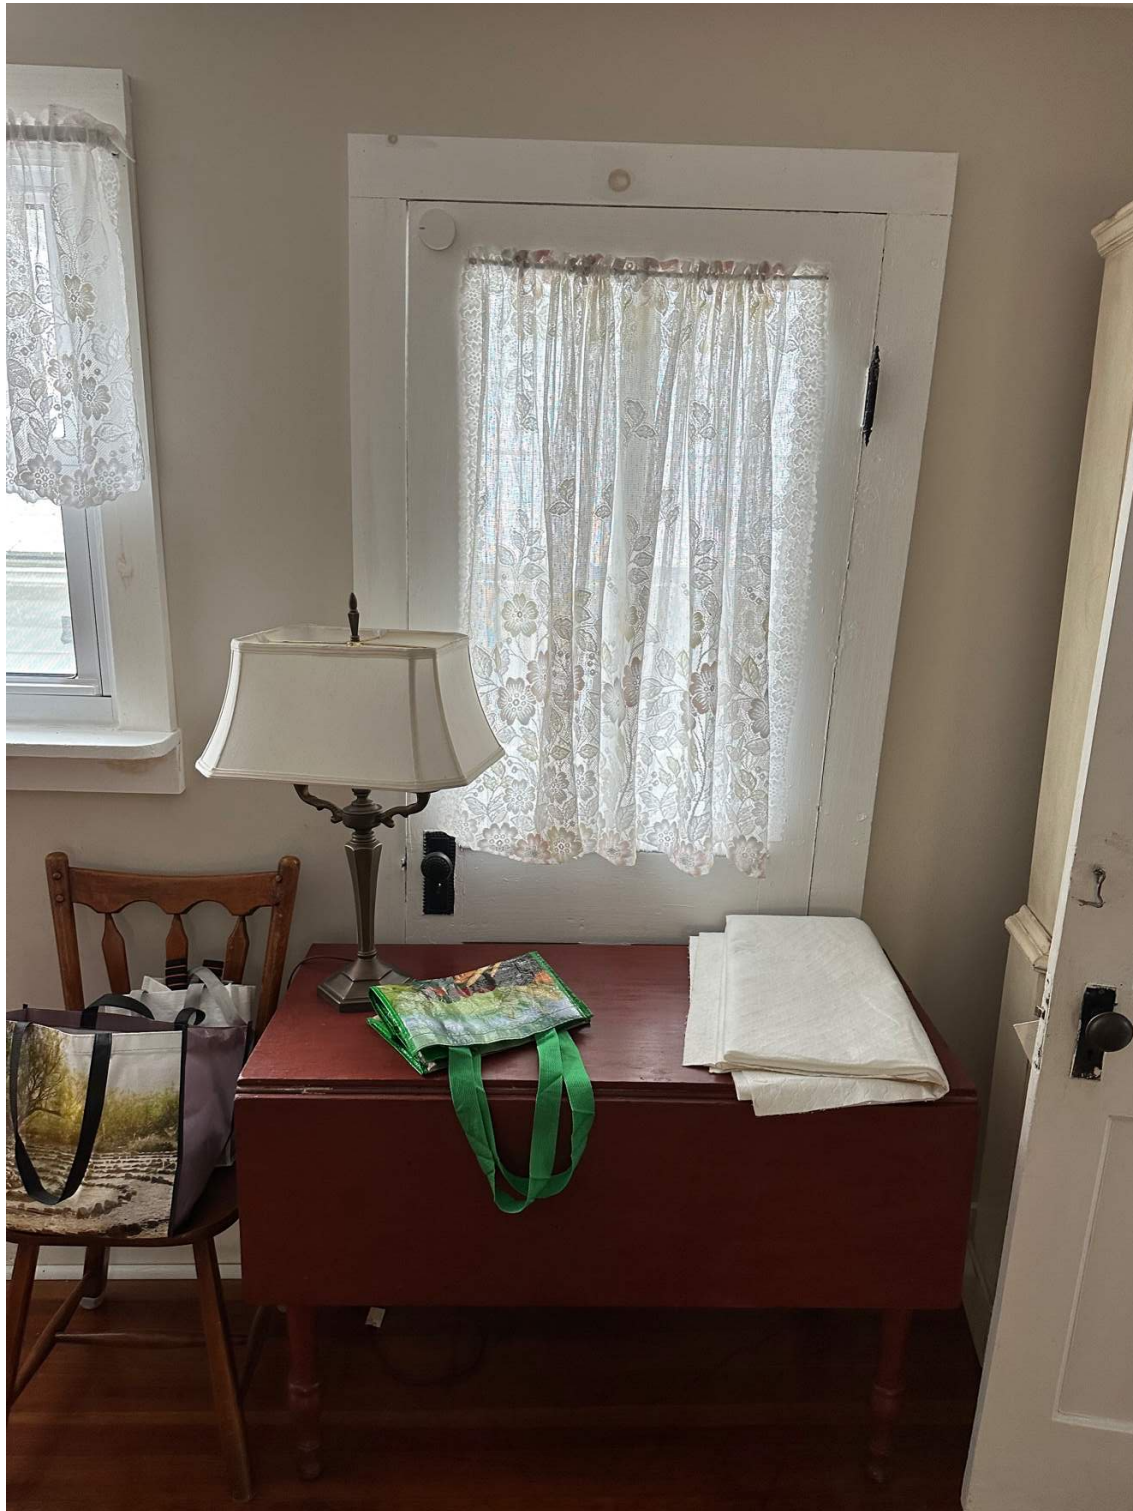
Blocked egress and poor air sealing (note light at left top of door)

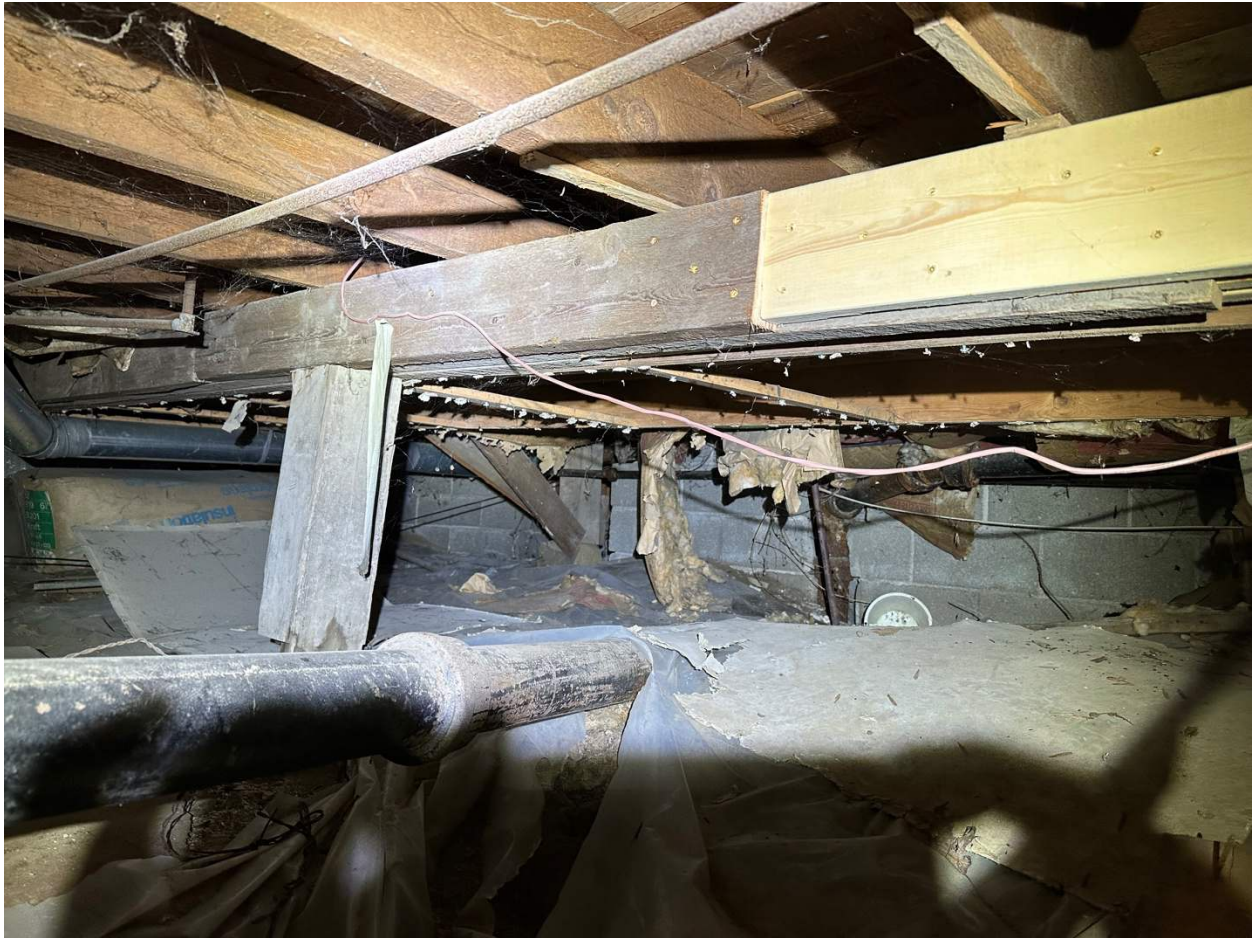
Added structural support to stiffen over extended floor joist  
Also shows post in the background bearing on stone

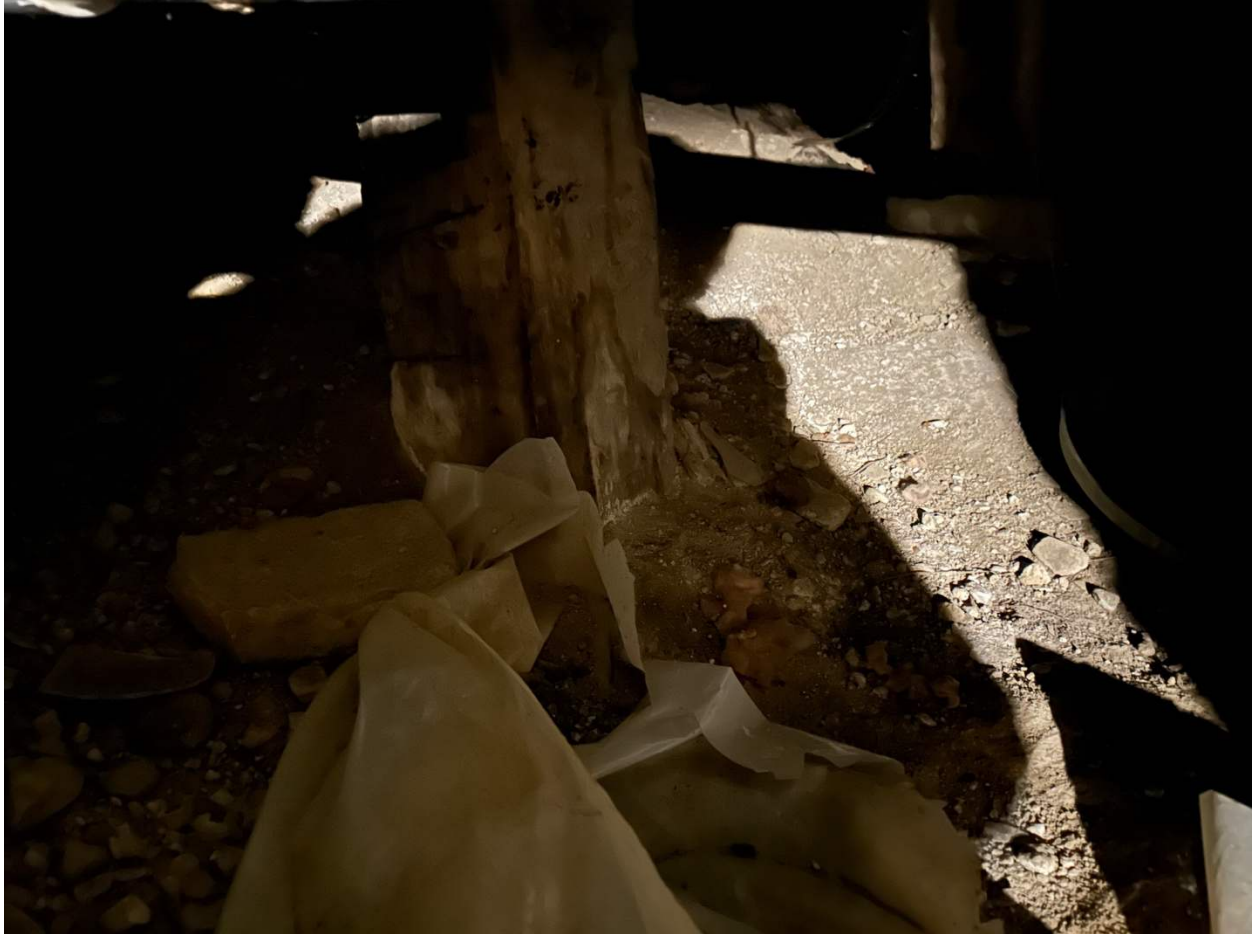
Untreated wood post bearing on soils

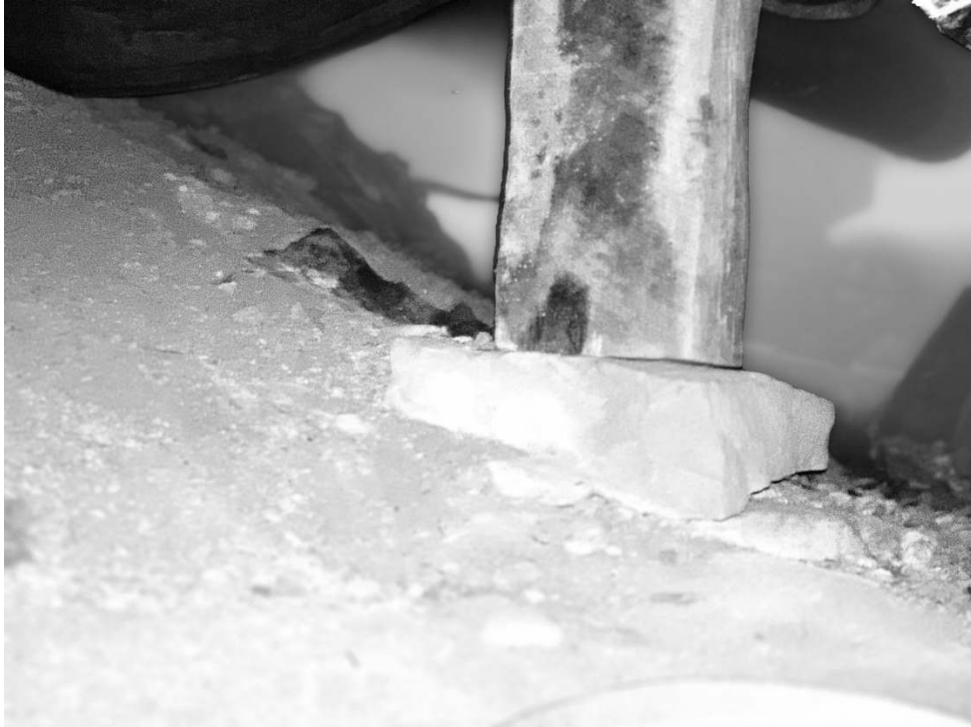
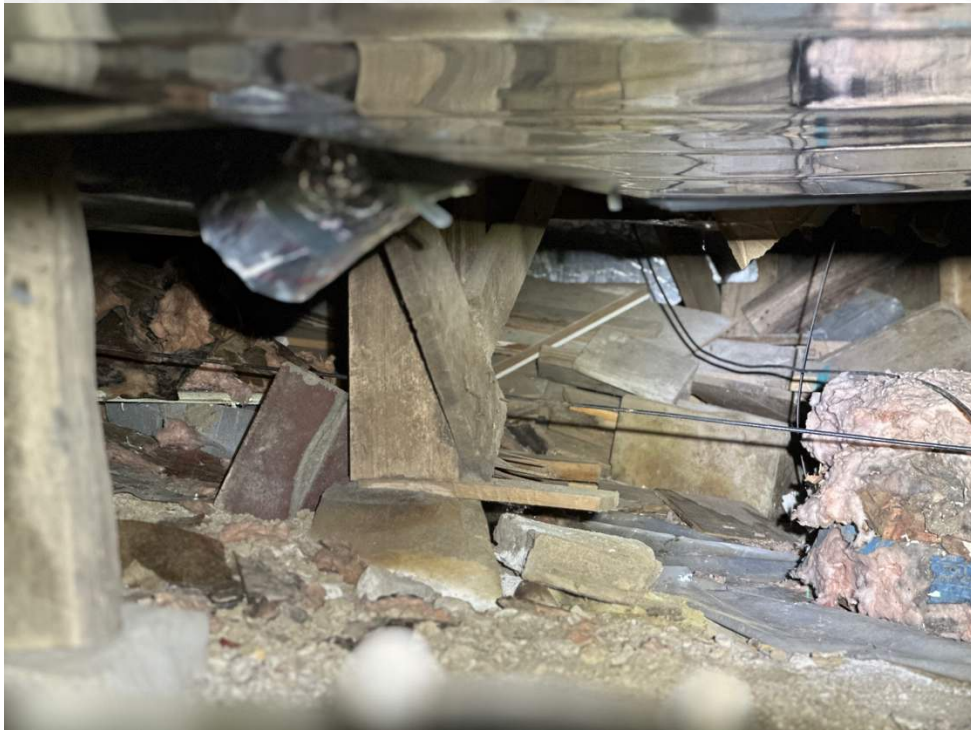
Untreated wood post on stone, does not resist uplift or lateral loading (no connection)  
No frost protection

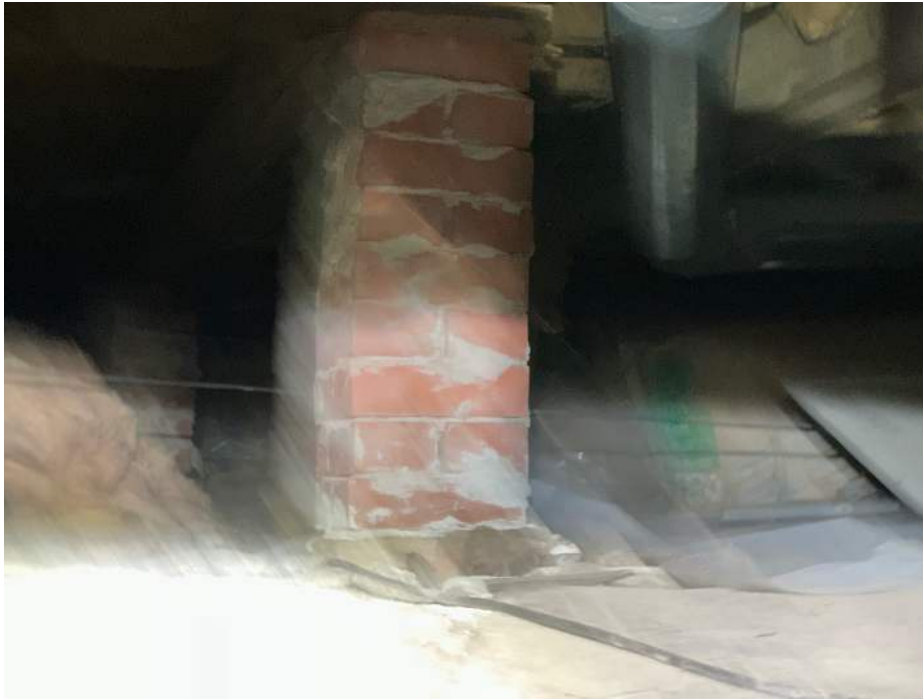
- a. Interior crawl space footings do not extend below frost depth, the footings are either cut stone or non existent

Masonry pier bearing on stone  
No frost protection

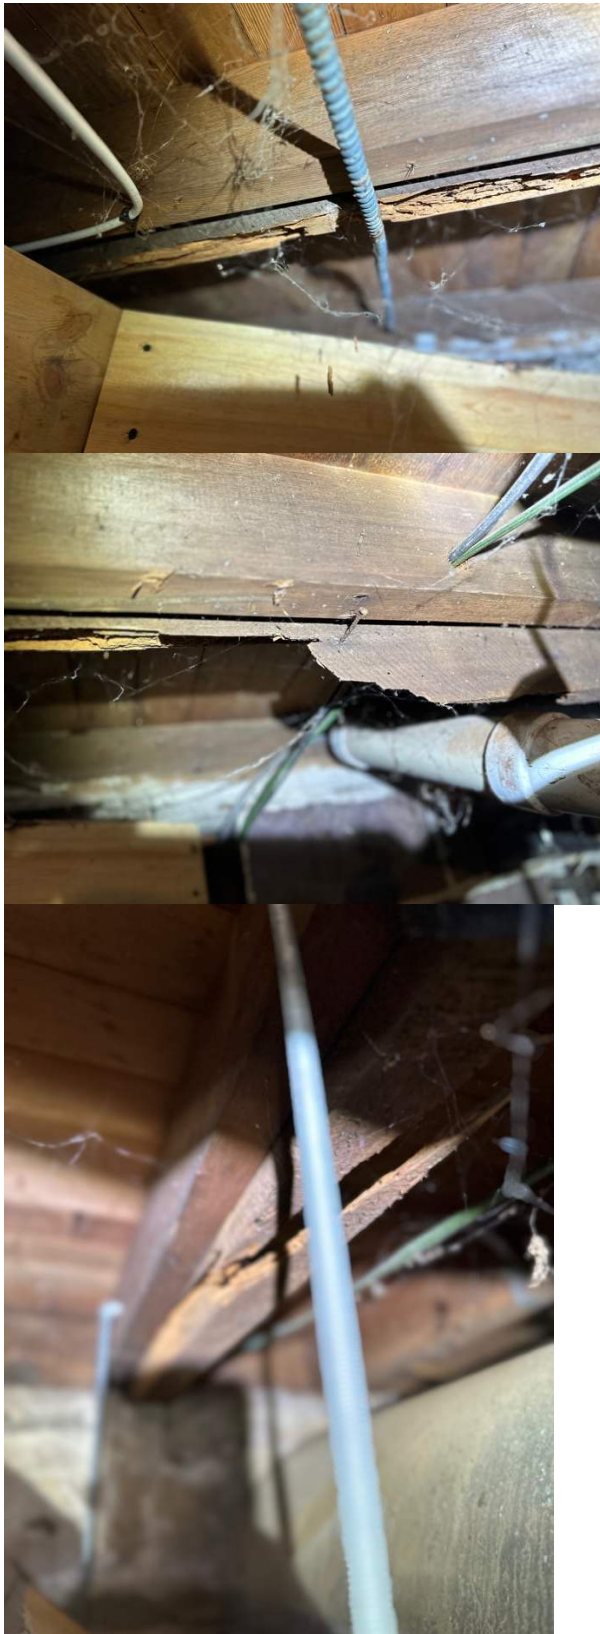
- First floor Joist in the old section of the structure are observable and show signs of deterioration, the joist in the mechanical crawlspace have been sistered as needed over the years and propped up with steel post and wood beams. In addition the joist in the rest of the crawl space have been supported with wood post and wood beams at mid span (post supported at grade w/o frost protection) Excessive deflections are evident and experienced as one moves about the structure the furnishings move and doors and widows creak. These floor joist are at less than 75% of the required strength required by

Deteriorated joist sistered

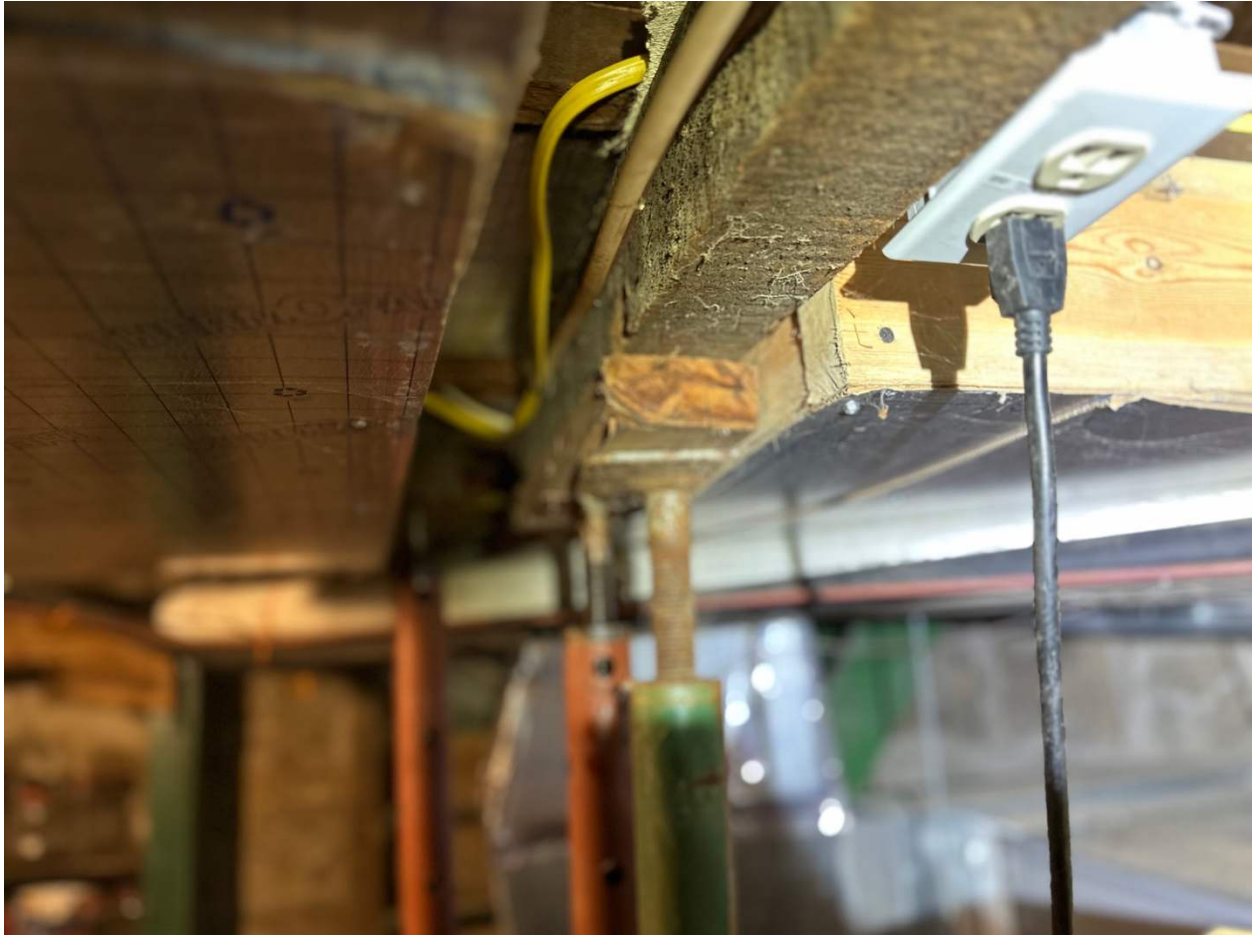
Support added to stiffen failing structure

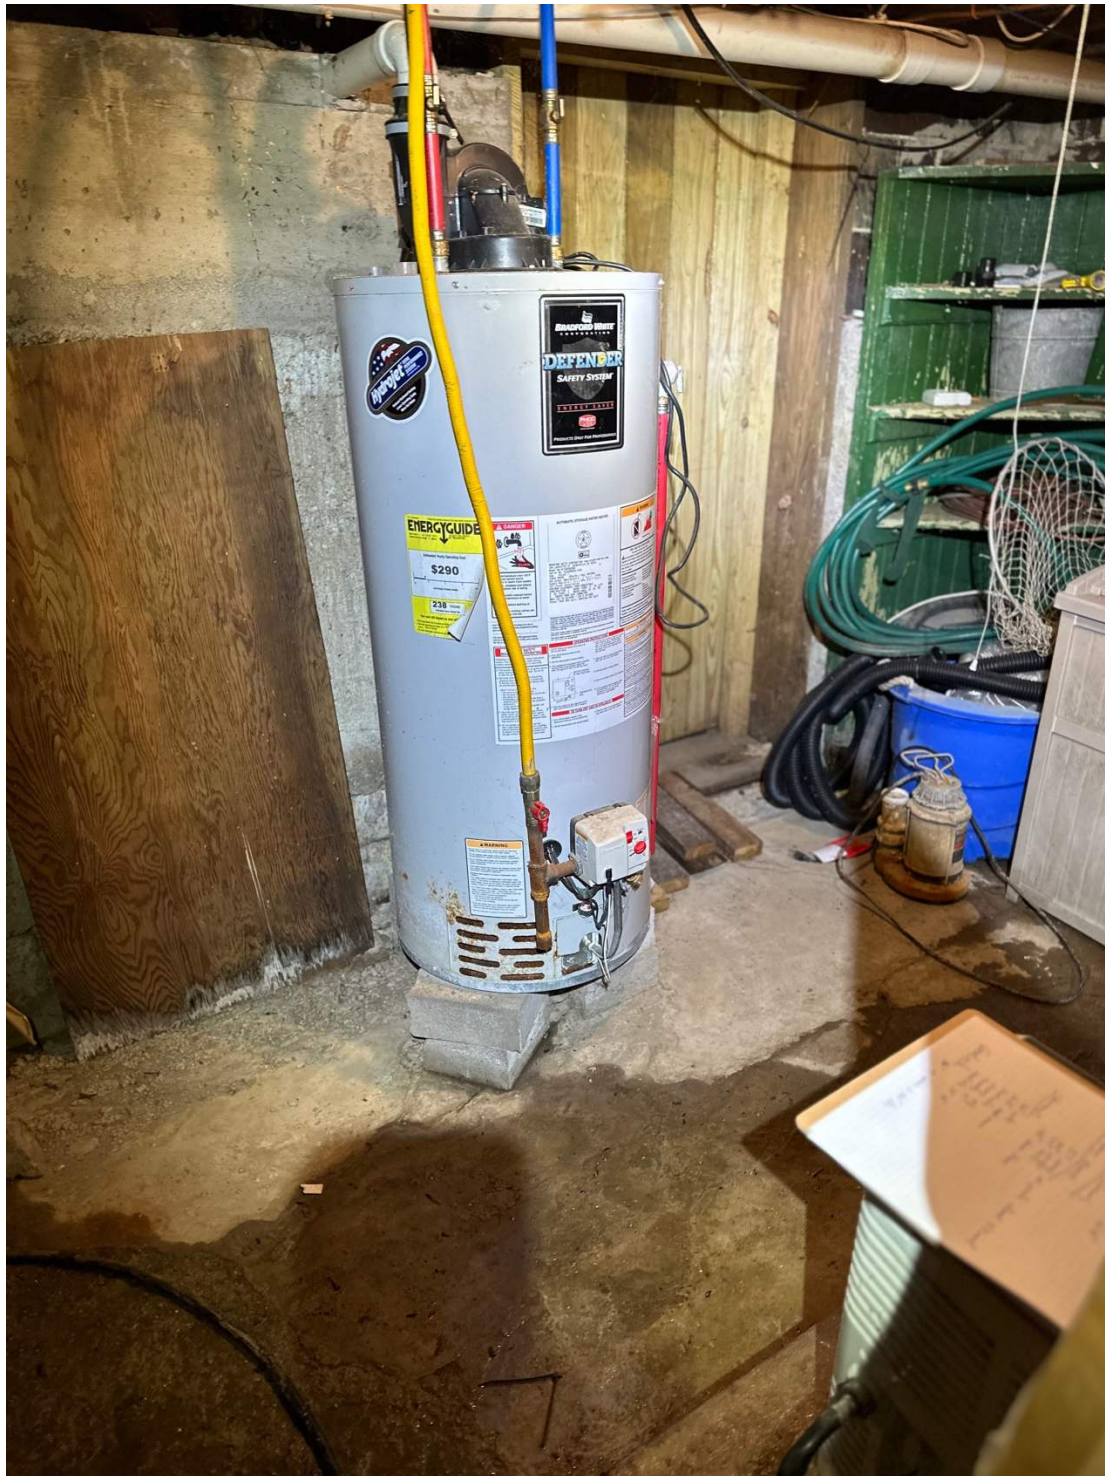
- a. The domestic hot water tank is a relatively new power vented unit
- b. Excessive moisture in the mechanical crawl space is causing excessive deterioration (rusting out) of the relatively new equipment
- c. Domestic water piping consist of a mix of modern PEX piping, copper and steel pipe (mostly abandon in place), the PEX piping is relatively new and has a good life expectancy. The copper piping appears to be at least as old as the 1995 revisions to the structure and has live 60% of its 50 year life expectancy. It is a messy installation

Hot water tank note rust at vent, on gas piping, and water on the floor

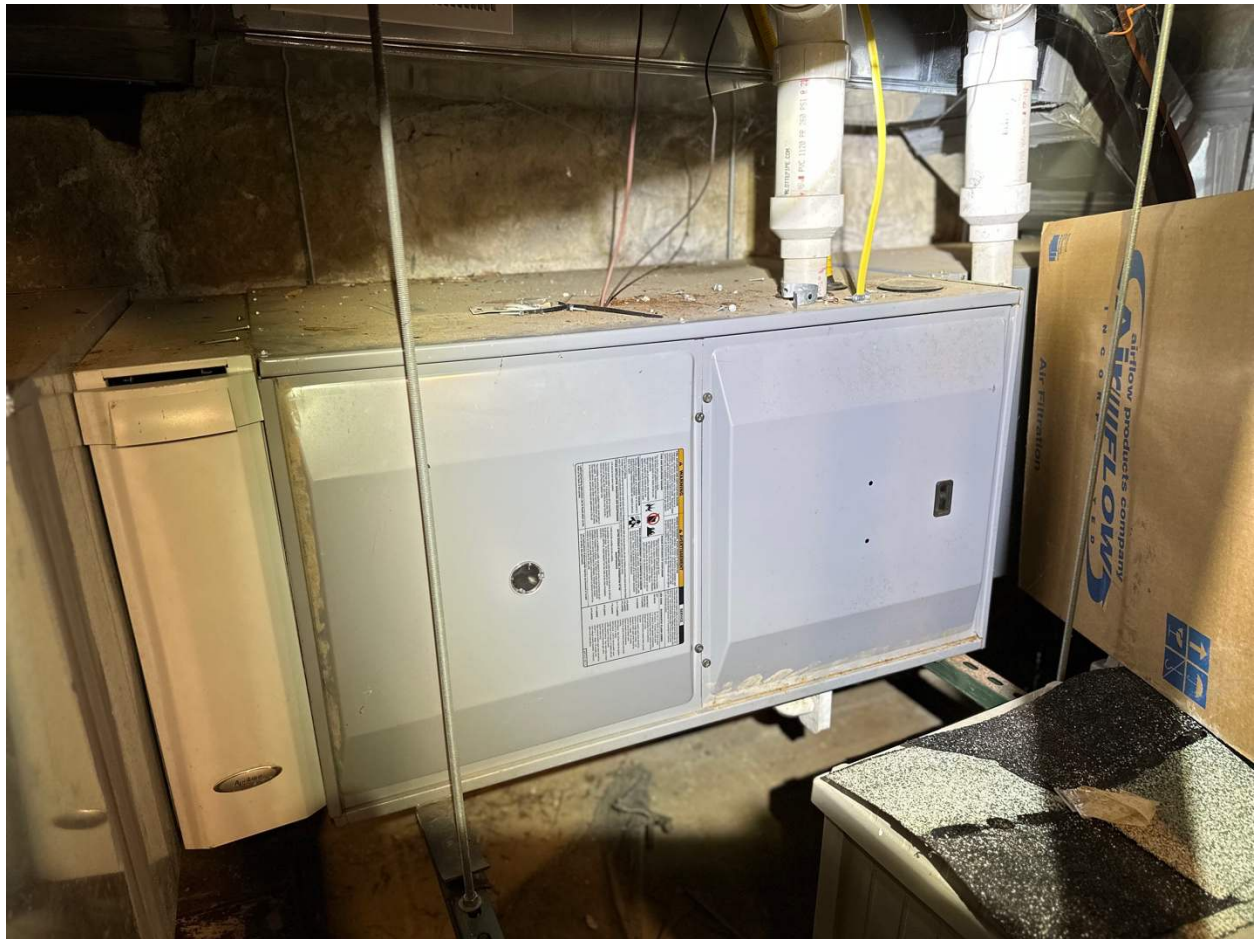
- a. Heating and Air conditioning systems are relatively new, a condensing furnace is providing heat with an exterior condensing unit and coil providing cooling, new ductwork is observable in the crawlspace.
- b. It is assumed that the amount of cooling reaching the second floor is inadequate as one of the occupant request is for additional cooling on the second floor. This could also be a function of air infiltration and inadequate insulation.
- c. Excessive moisture in the mechanical crawl space is causing excessive deterioration (rusting out) of the relatively new equipment

Condensing furnace note rust on bottom right

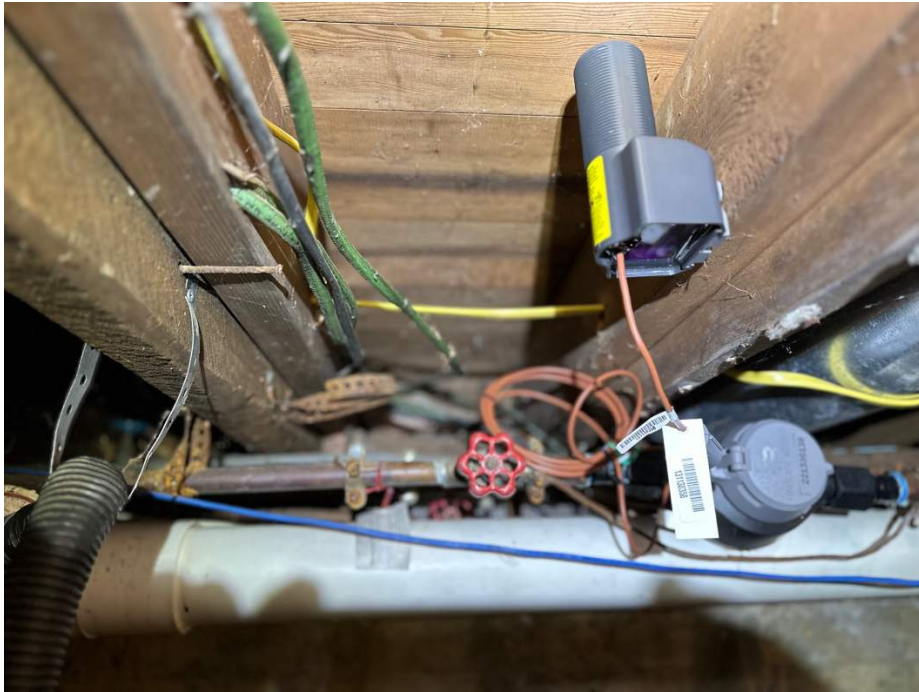
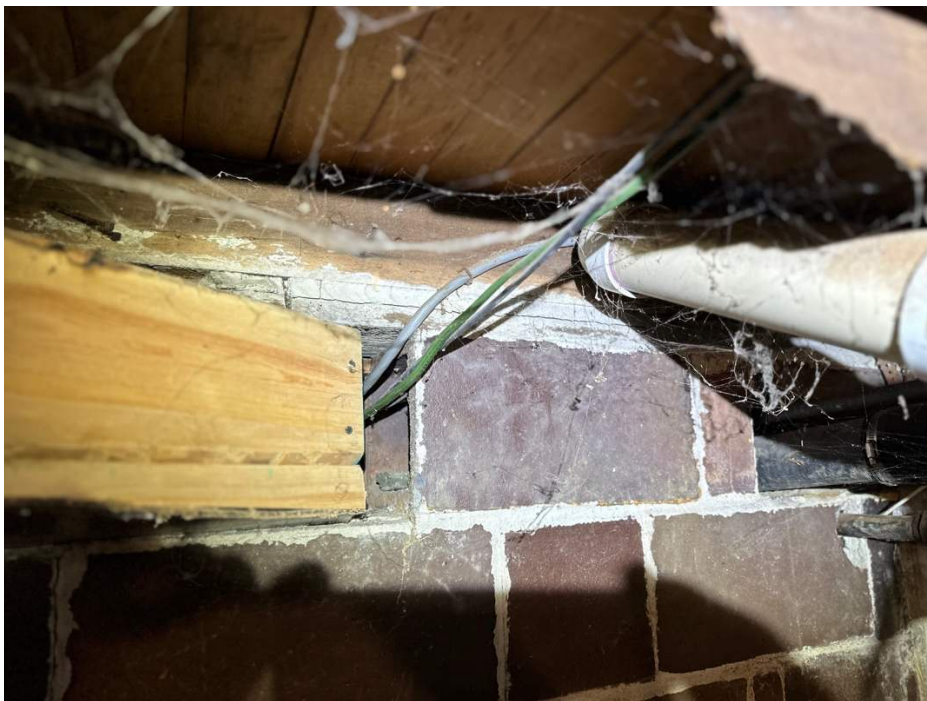
- a. Electrical systems vary in age and quality of material, it is a messy installation with the system being added to and changed over the years. No knob and tube wiring was observed, although most of the branch wiring is concealed and could only be observed through investigative demolition.

Variety of wiring

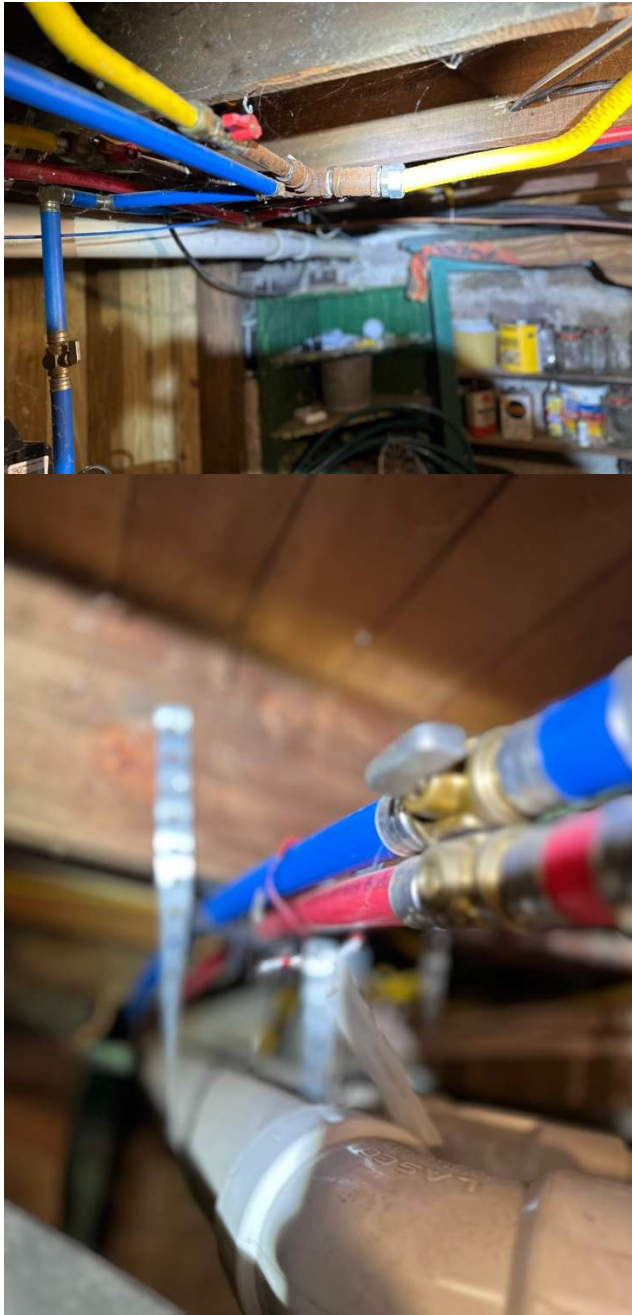
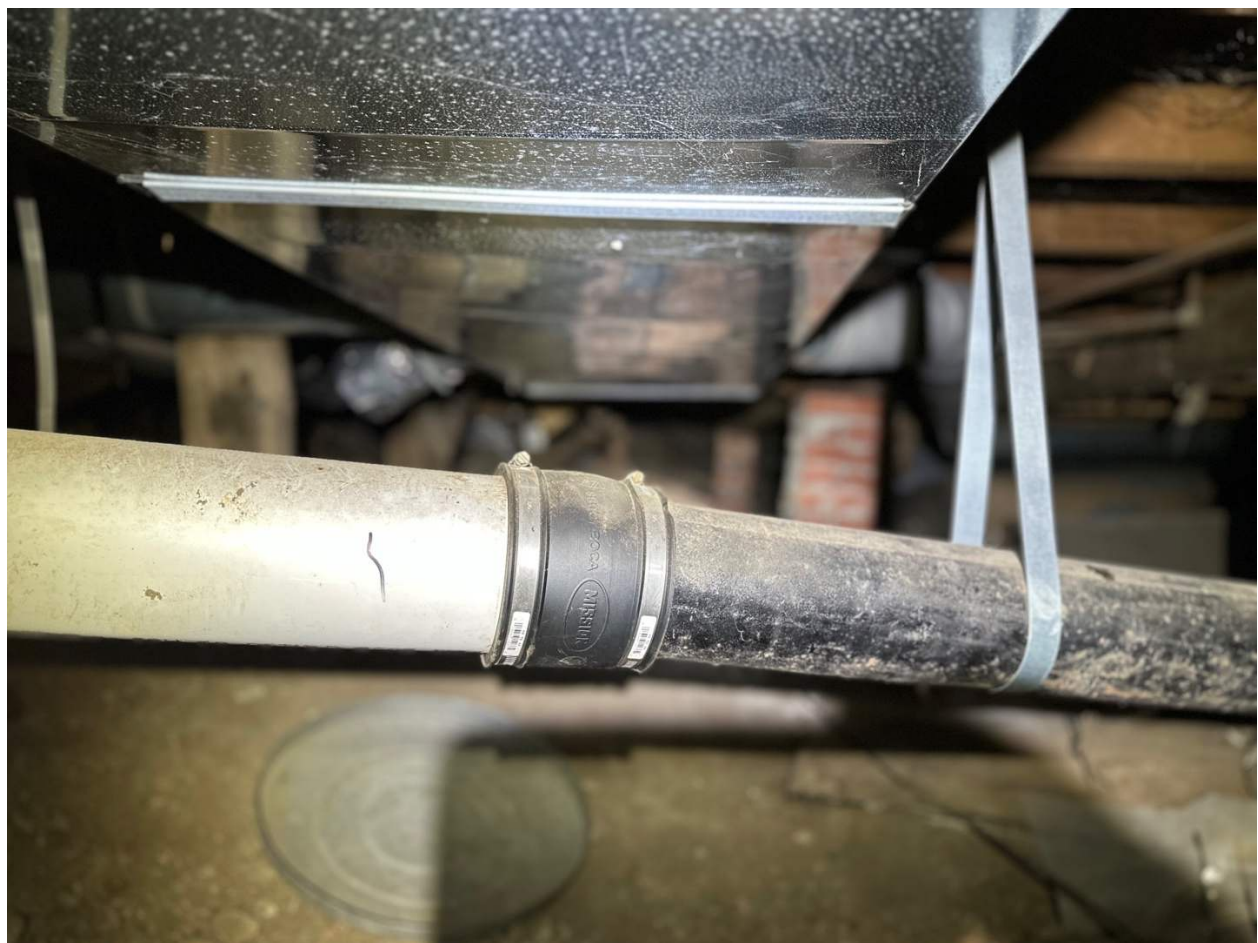
Variety of gas water and waste piping
