**BUILDING CONDITION REPORT**  
**25 VINCENT, CHAUTAUQUA**  
**SEPT, 2023**

# 25 Vincent Ave

## 2020 Residential Code of New York synopsis

## 25 Vincent Ave Summary 09.25.2023

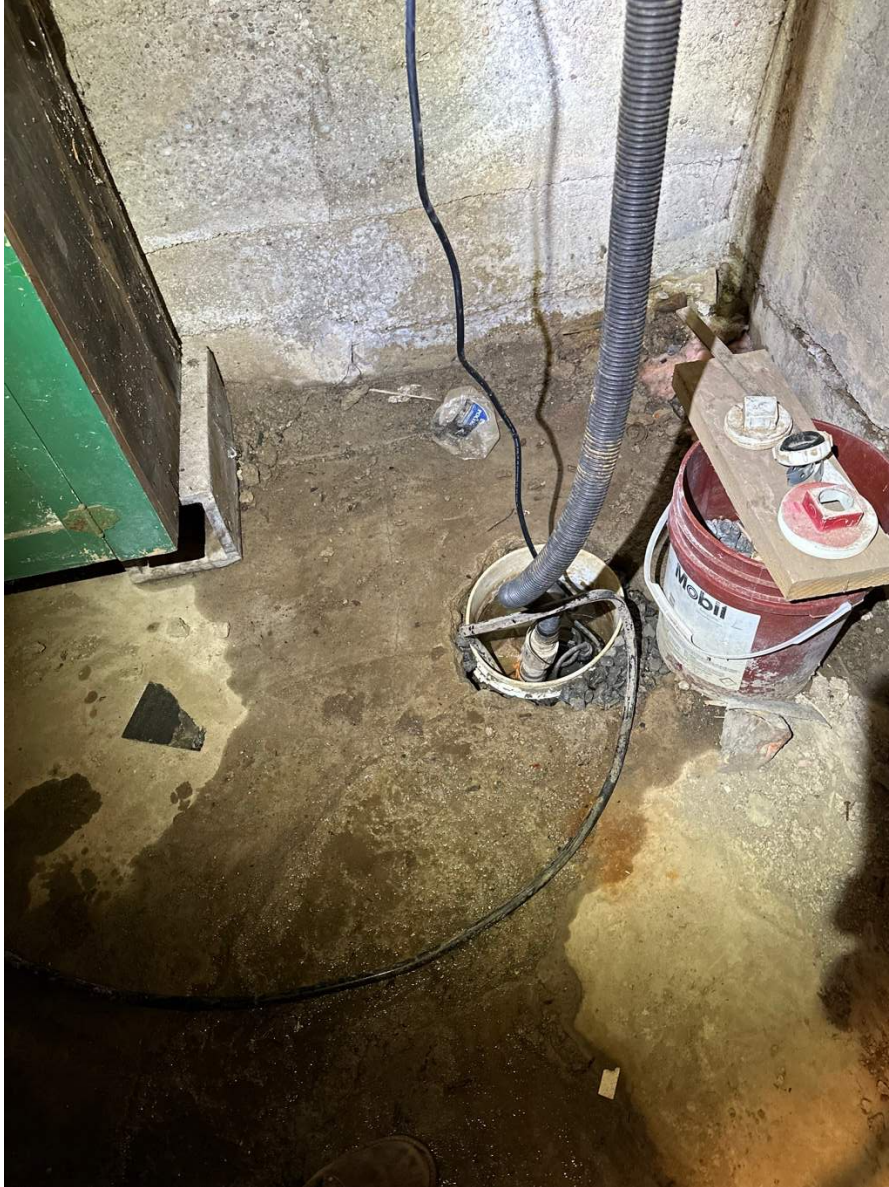
- a. There is no evidence of a foundation drainage system other than a sump crock (5gallon bucket) that was added at a later date (water runs freely and consistently through the mechanical crawl space.)

5 Gallon bucket sump crock!

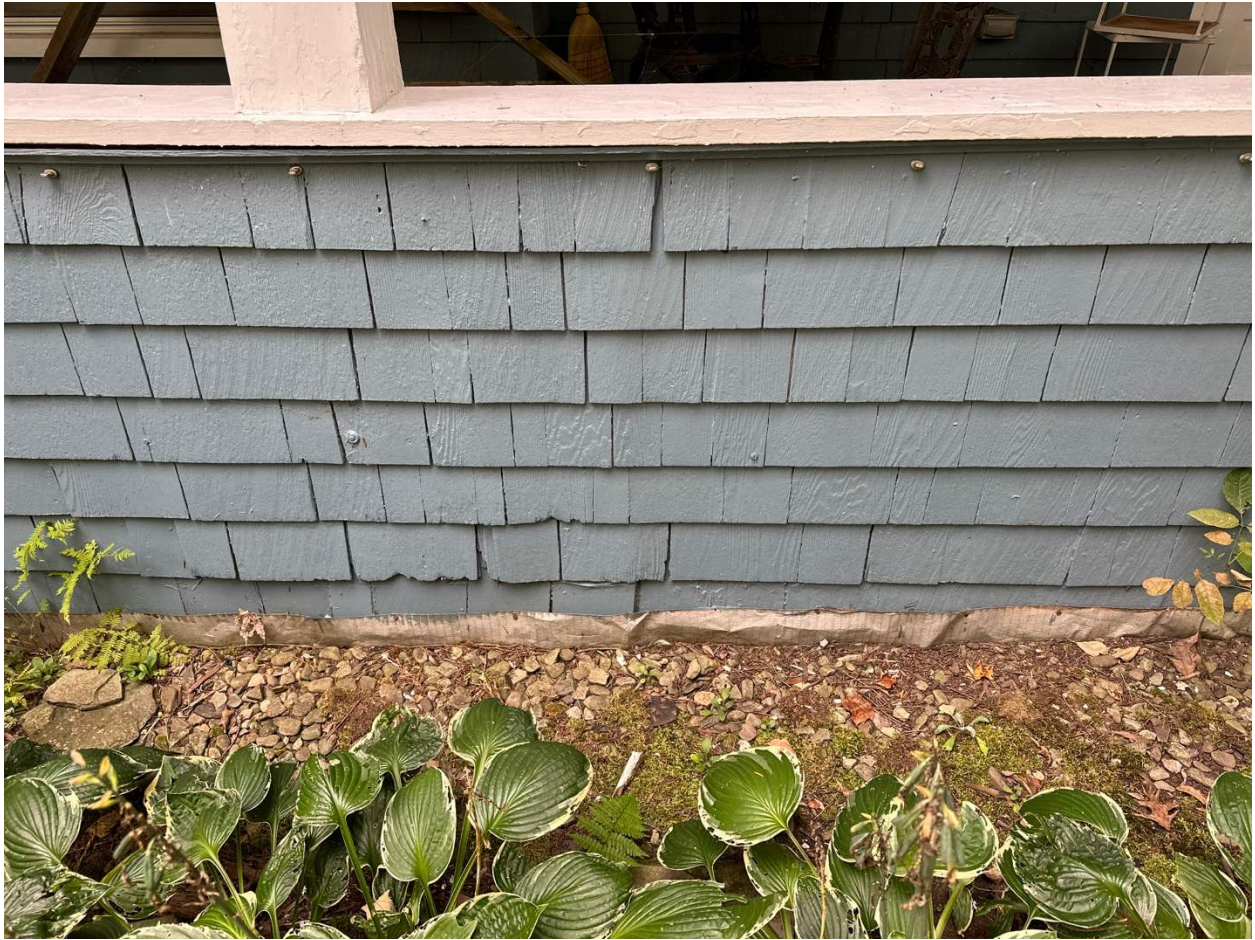
- a. There is no evidence of compliance with items 1-3 & 5-6.
  1. Structural wood closer than 18" to exposed ground in crawl spaces
  2. Wood members resting on masonry
  3. Sills or sleepers on masonry that is in direct contact with ground
  5. Wood siding closer than 6" to the ground
  6. Wood structural members supporting moisture permeable floors exposed to the weather

Wood too close to ground
